Evaluating ADL System Iridium Performance

Version 1.00

30.10.2019

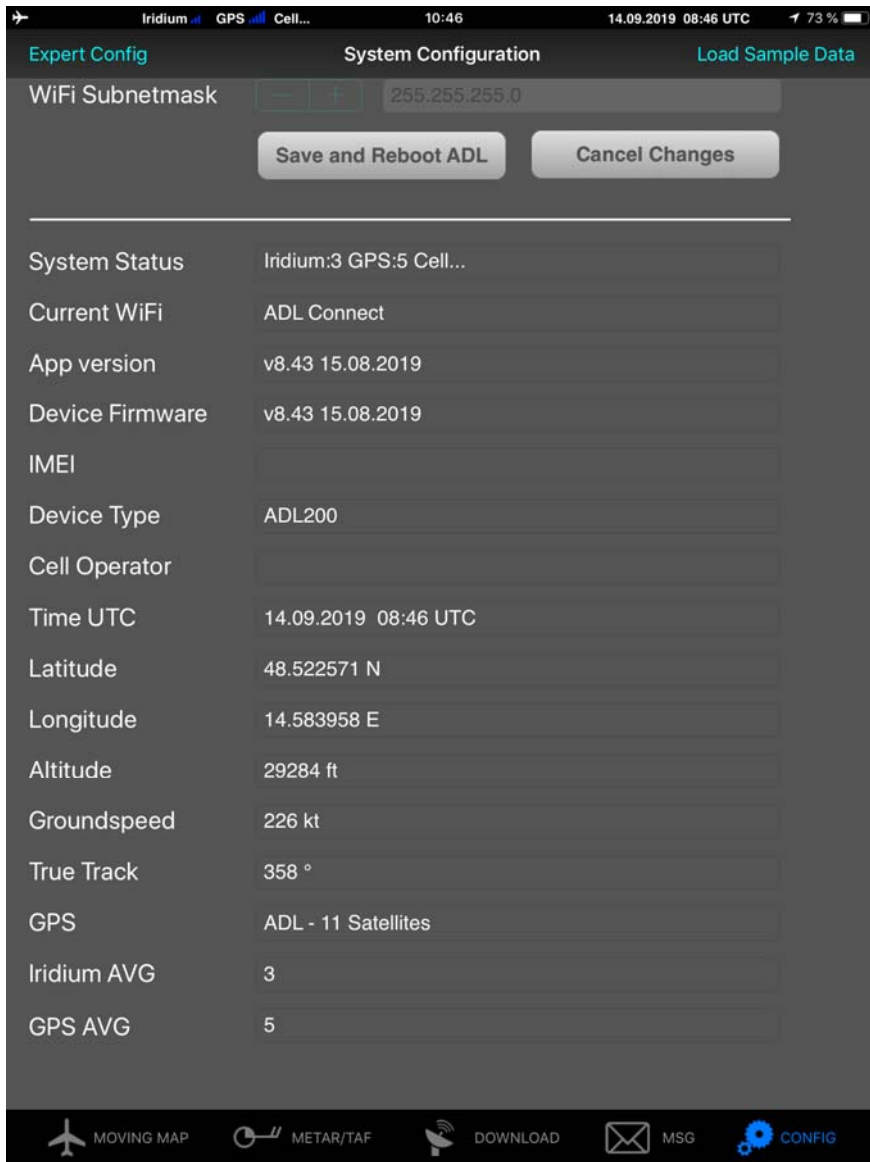
Figure 4 An example of very solid performance obtained in flight on our own aircraft.

If the plane is close to a hangar our experience is that you can usually expect 1 Iridium bar on average only. An external Iridium antenna on the hull usually increases the average by about 1 bar. On a "perfect" installation the best we did observe so far in flight was Iridium AVG 4-5 bars and GPS AVG 5 bars.

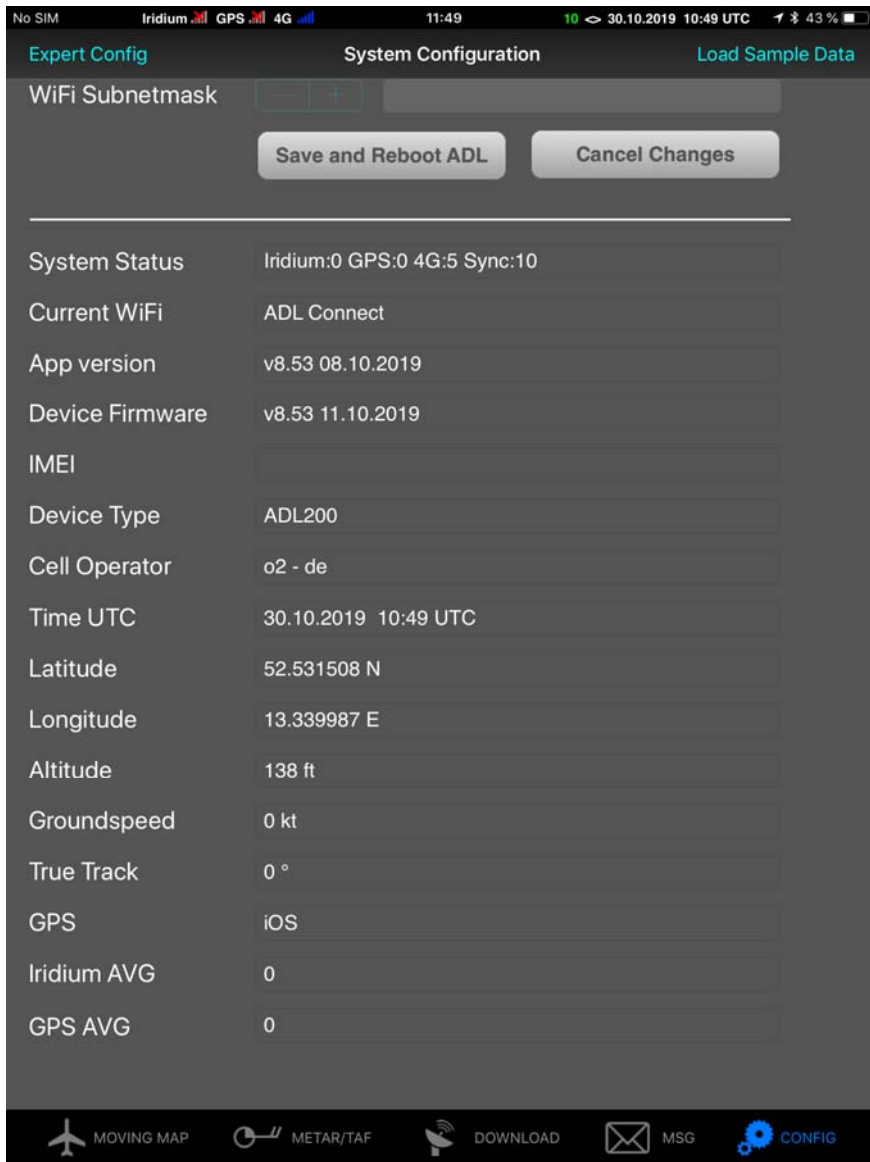
Figure 5 An example of very poor performance which needs investigation

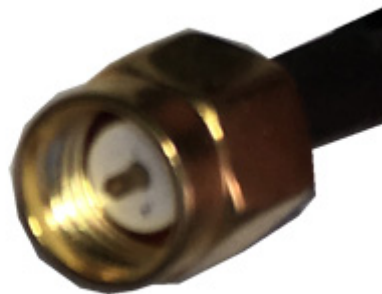
Figure 6 SMA connector with properly located center pin

Except for the ADL140 the single most common defect relates to the Iridium antenna connector. If there was too much tension on the cable the SMA connectors can get damaged. We have also seen tiny dirt particles in the connectors causing signal loss. The most crucial point is the tiny central pin which should not be retracted or similar. Besides that please check the cable for any tight bends or other defects. Sometimes just reattaching the connector solves the problem.

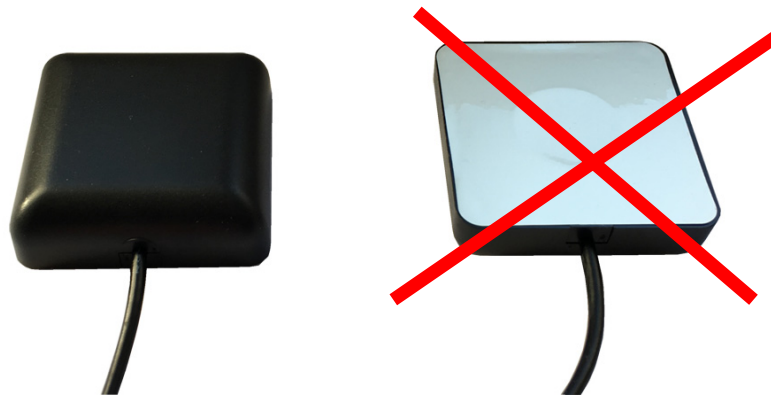
Figure 7 Proper Iridium antenna orientation (left side)

The patch Iridium antennas we use have to be oriented towards the sky. They radiate only to one direction so please make sure the antenna is not upside down. Also the antenna should be as horizontal as possible. For example tilting the antenna 90 to the side will result in massive signal loss for all situations when the satellite is on the other side.

As the ADL140 contains the antenna in that case the orientation applies to the whole ADL140 device where the black sticker should face downwards.

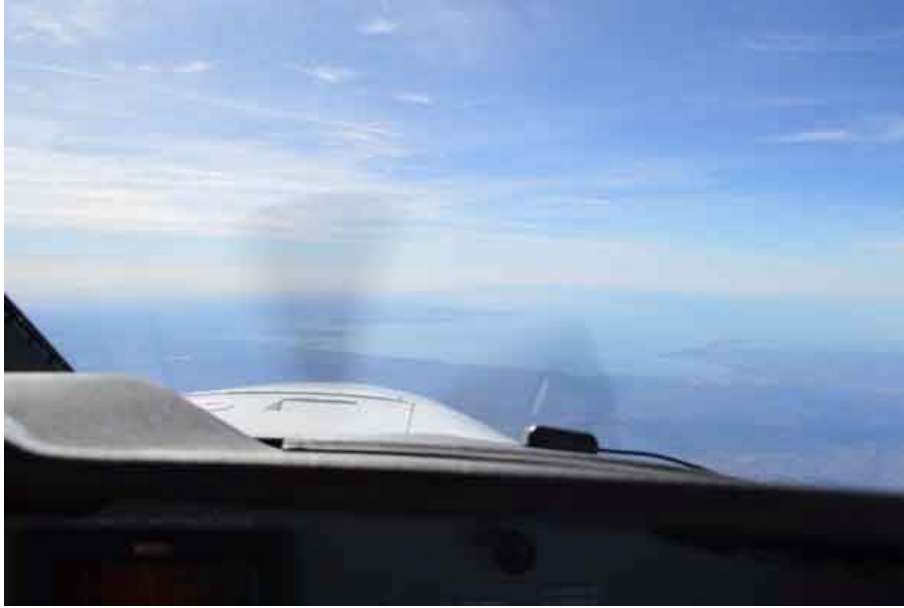
Figure 8 Typical Iridium antenna location in that case slightly right of centerline but still acceptable

Unless any special obstruction in the cockpit requires another solution, we have found that the best place for the internal Iridium antenna is all the way forward below the windshield more or less in the middle of the aircraft.
